**Above and Above Left :** General view of the church from the west and south west (Church Street).

**Left :** View from south east showing the east end of the church, Church Street and the ancient well below churchyard.

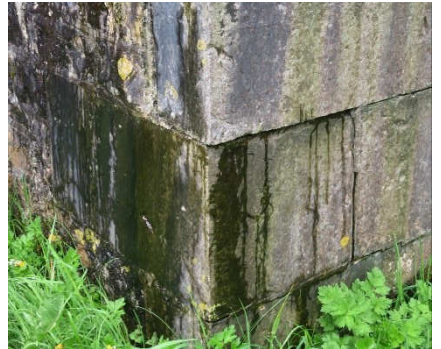
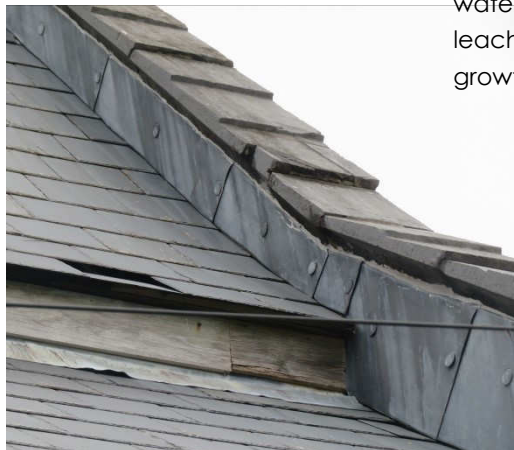
**Left :** Silicon jointed flashings not performing well against undercut copings. Missing slate.

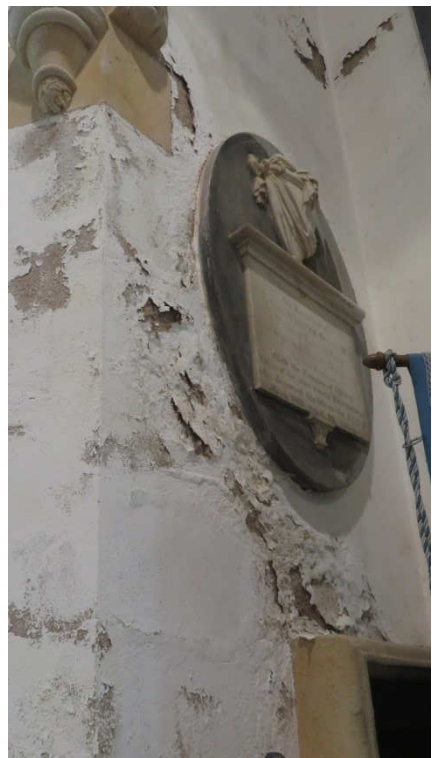
**Right :** Damage to wall plaster, decorations, stonework, timberwork. Monuments becoming more vulnerable.

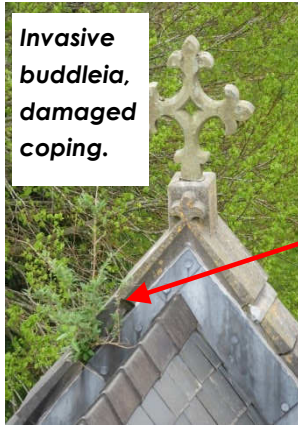
**Invasive buddleia, damaged coping.**

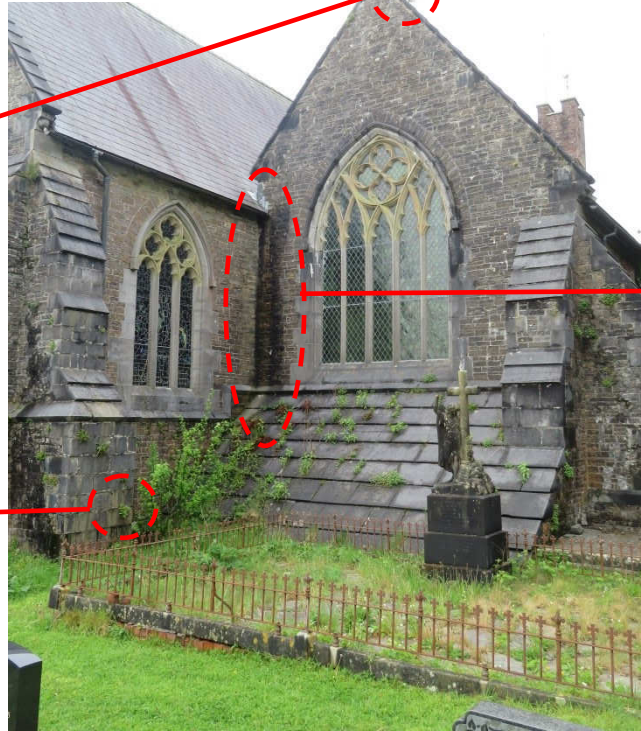
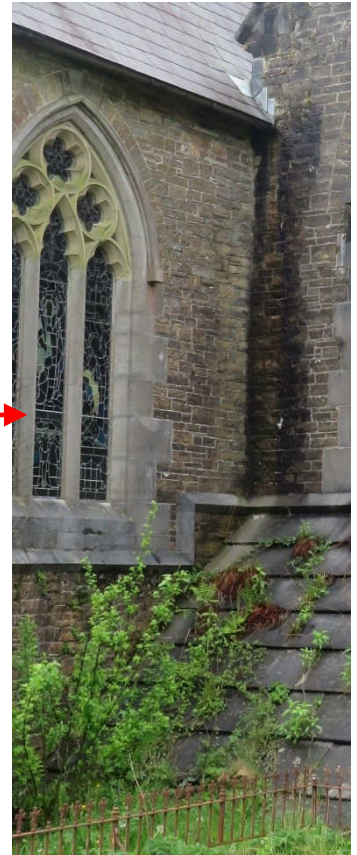
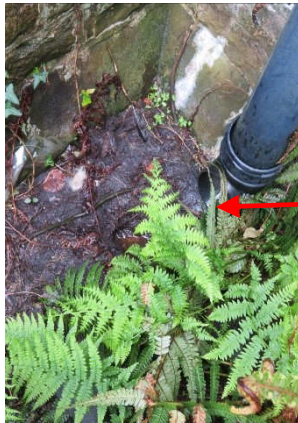
**Above :** Blocked gully causing saturation of footings and walling and consequent damage internally.

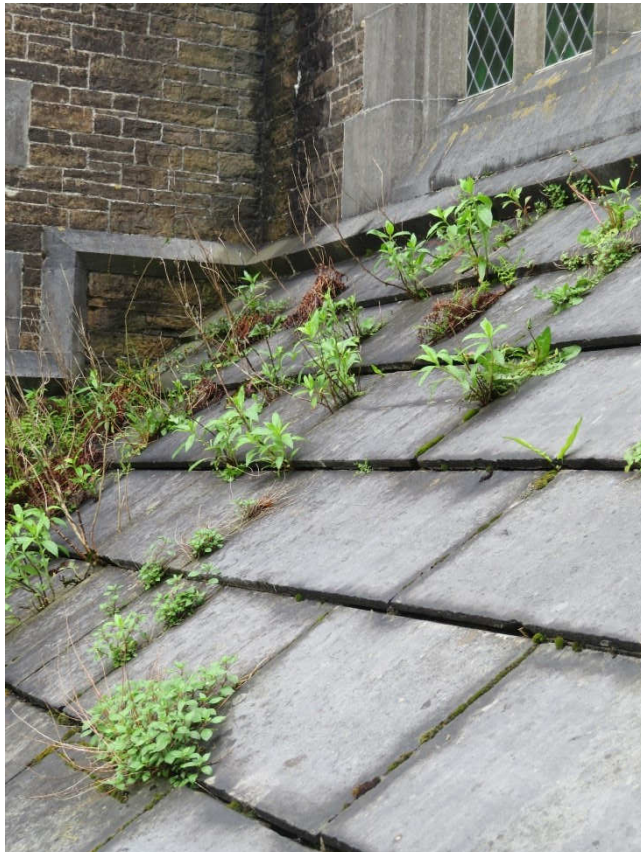
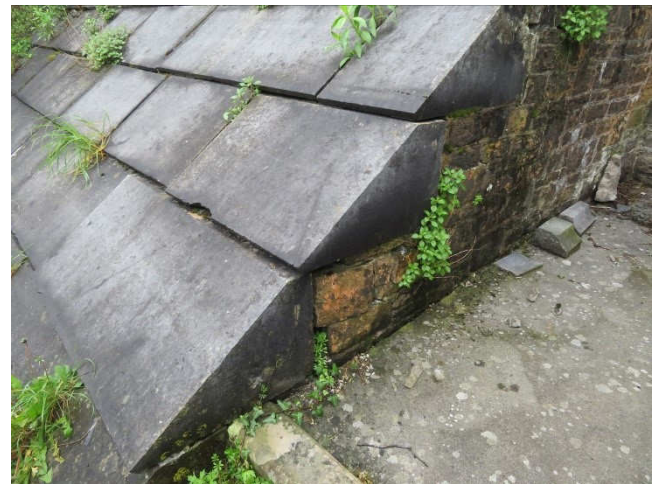
**Left :** Stone tabling over the Dinefwr vault is very vulnerable to damage from vegetation and washing out of joints.

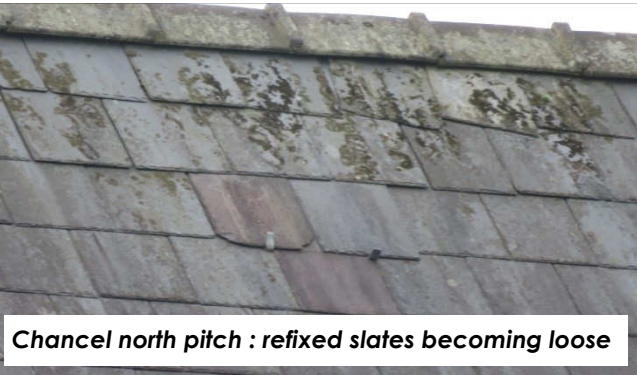
Chancel north pitch : refixed slates becoming loose

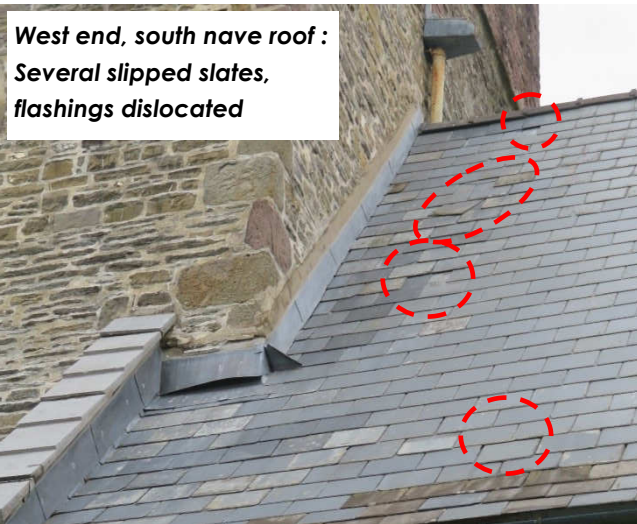
West end, south nave roof : Several slipped slates, flashings dislocated

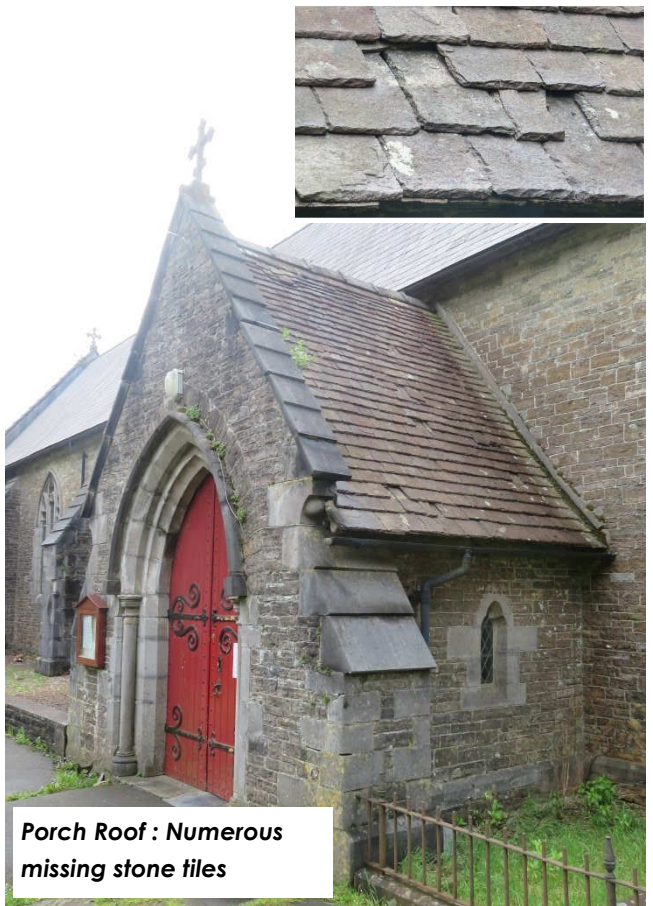
Porch Roof : Numerous missing stone tiles

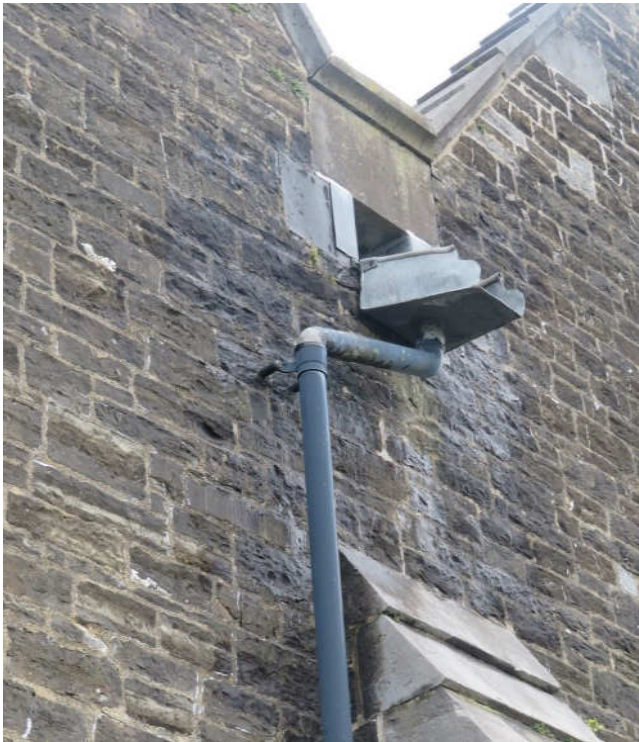
**Above :** Hopper serving the valley over the south chapel / former organ chamber roofs. Saturation to walling after rain indicates the system is not wholly effective and likely contributing to the dampness evident internally (see plate 8).

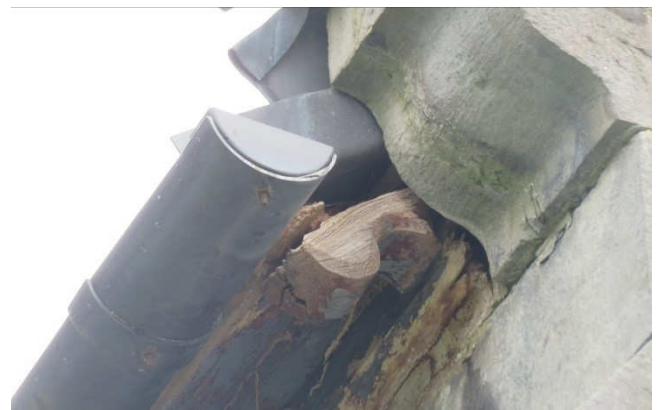
**Above :** Timber decay threatens gutter fixings. This is the south chapel gutter, similar issue to north aisle.

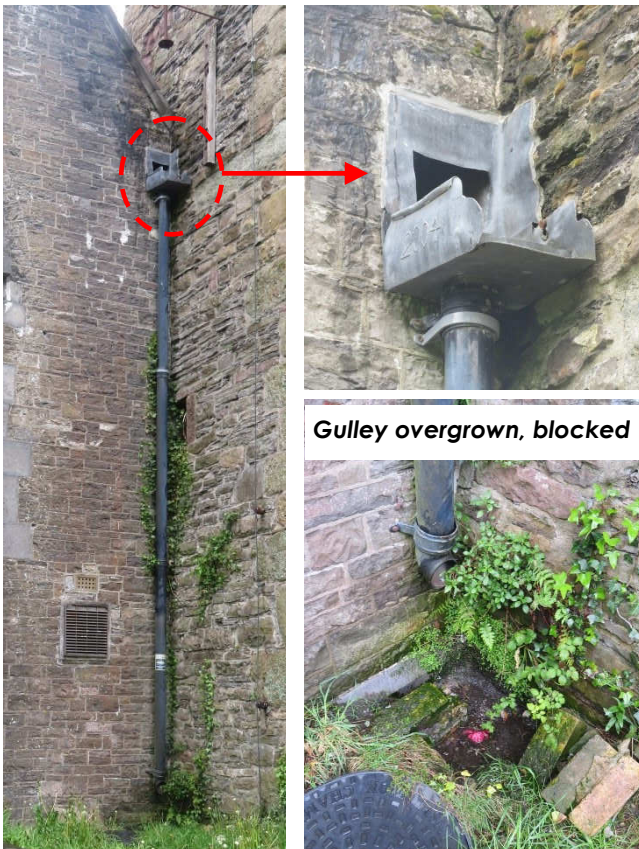
**Above :** West end. Extensive vegetation growth shows that rainwater goods are not operating fully.

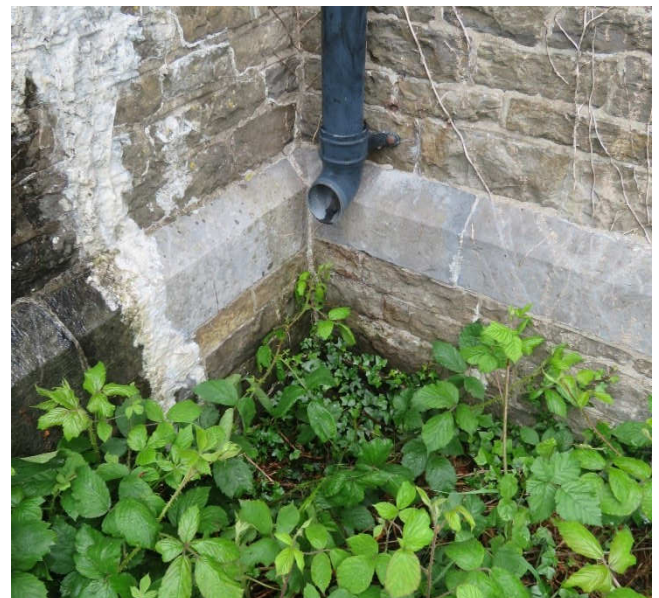
**Above :** Gully on the southern side of the church. Many of the church gulleys are heavily blocked, in need of clearance and repairs. Drains should be tested for effectiveness.

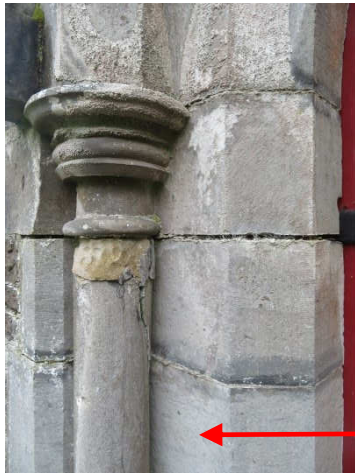
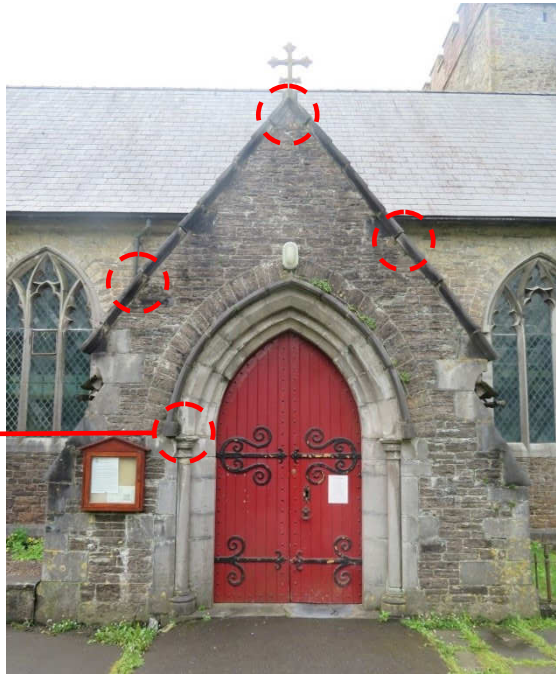
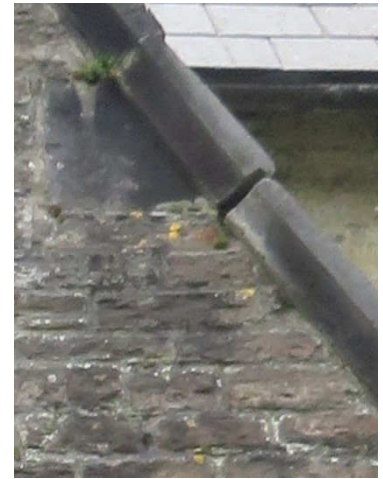
**Above :** Detail of enlarged open joint to coping stones.

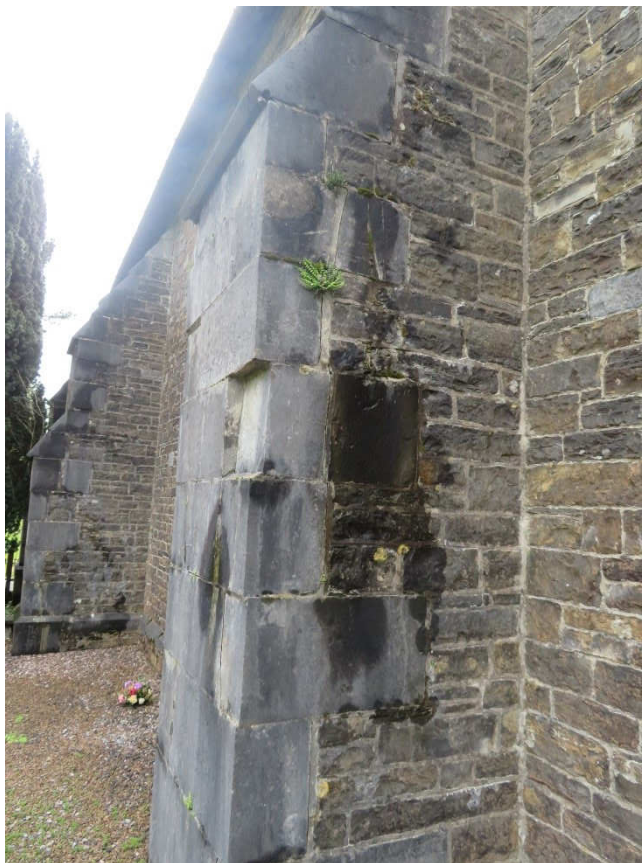
**Above :** Damaged Carboniferous stonework to buttress, water weeping after rainfall.

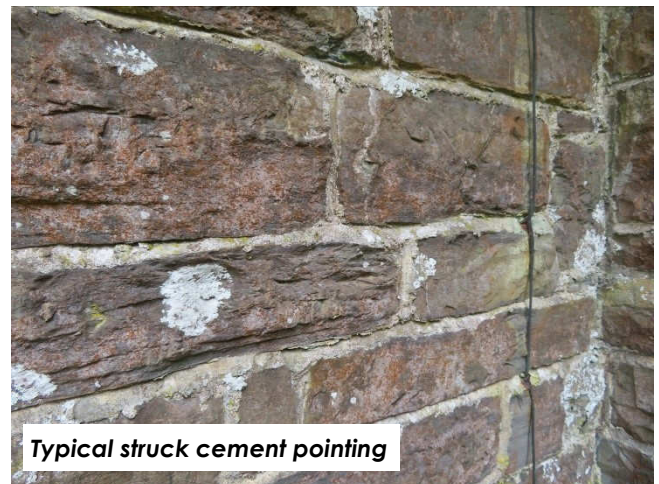
**Typical struck cement pointing**

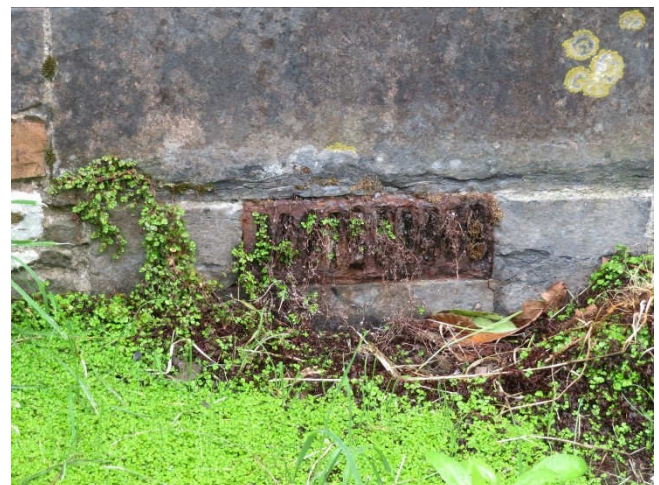
**Above :** Wall vents rusted up, no longer ventilating beneath the floors.

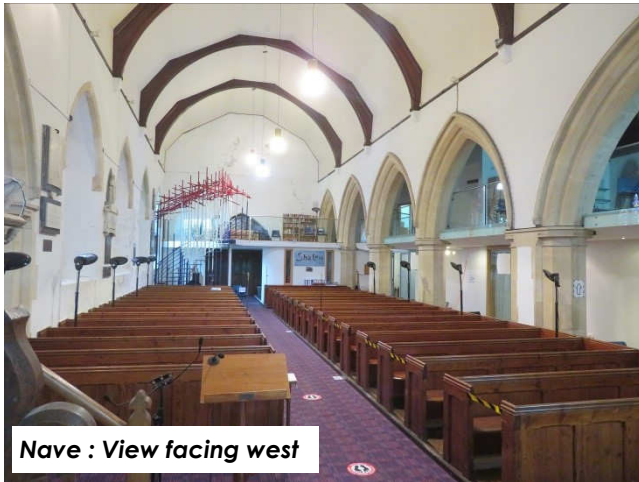
Nave : View facing west

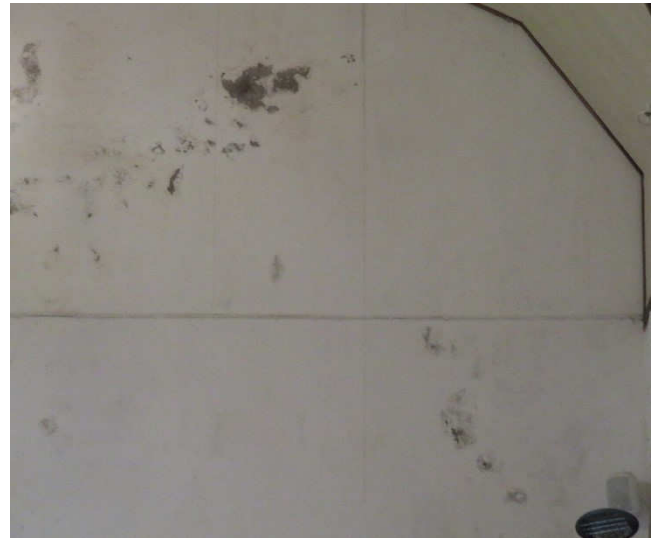
Above : Water damaged decorations and plasterwork to the west nave wall, abutting the tower.

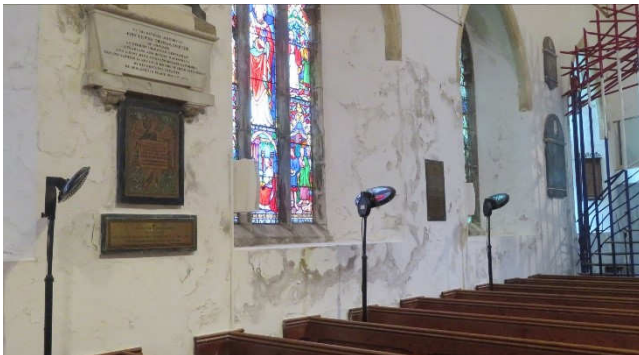
Left : Water damaged decorations and plasterwork to the south nave wall, window sills etc.

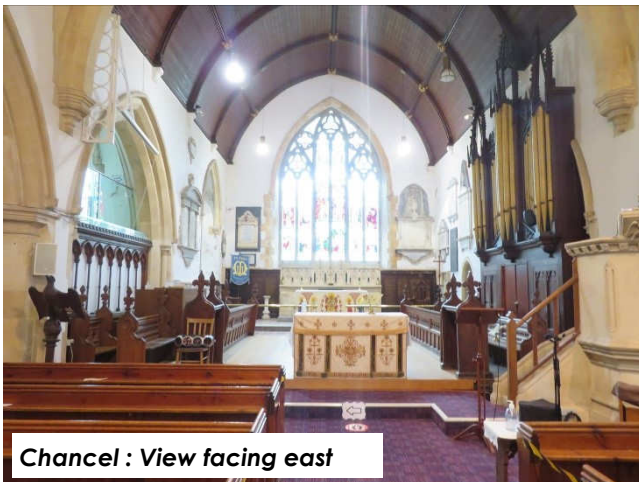
Chancel : View facing east

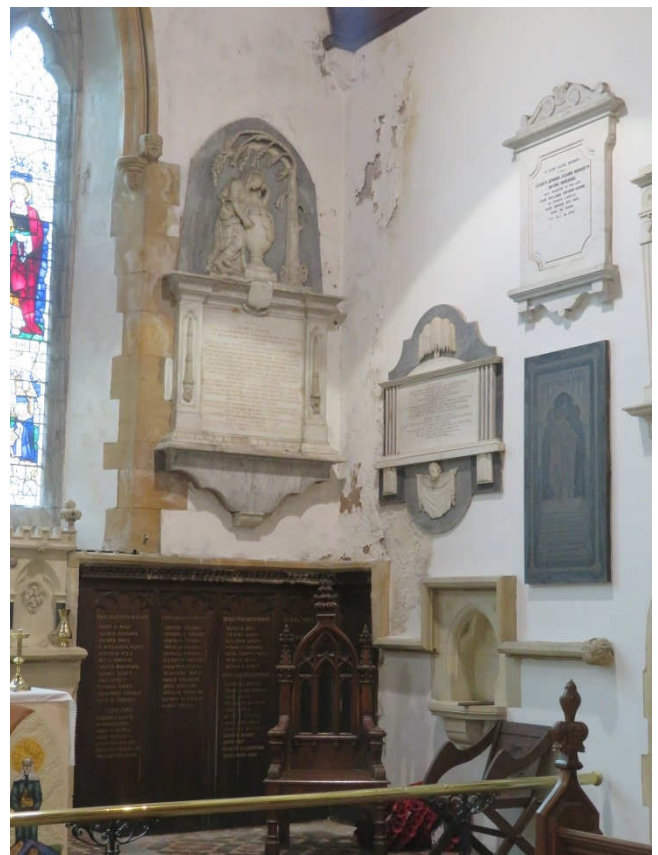
Above : South east corner of chancel : Water ingress damaging plasterwork and decorations, stonework, causing decay to memorial panelling and threatening the wall mounted monuments.

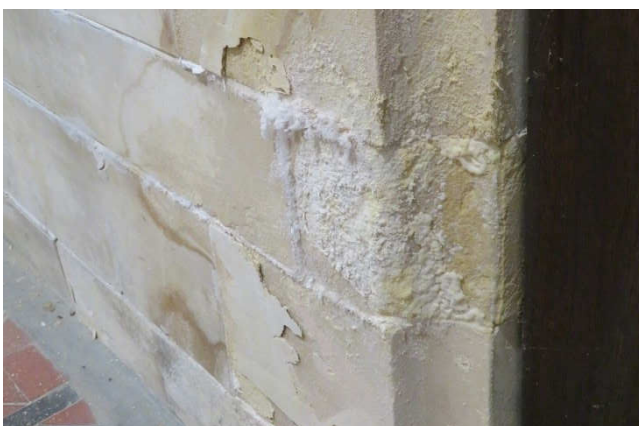
Above : Dampness, salts damaging the stonework both sides of the reredos.

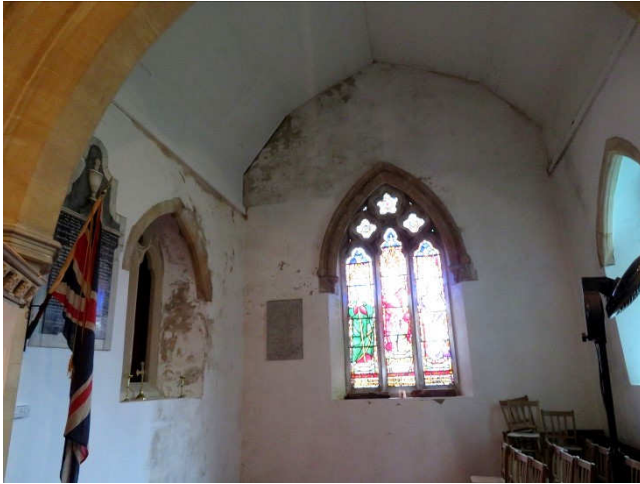
**Above :** South chapel. Leaks have recently been attended to, but water ingress may continue associated with the outlet / hopper externally (see plate 5).

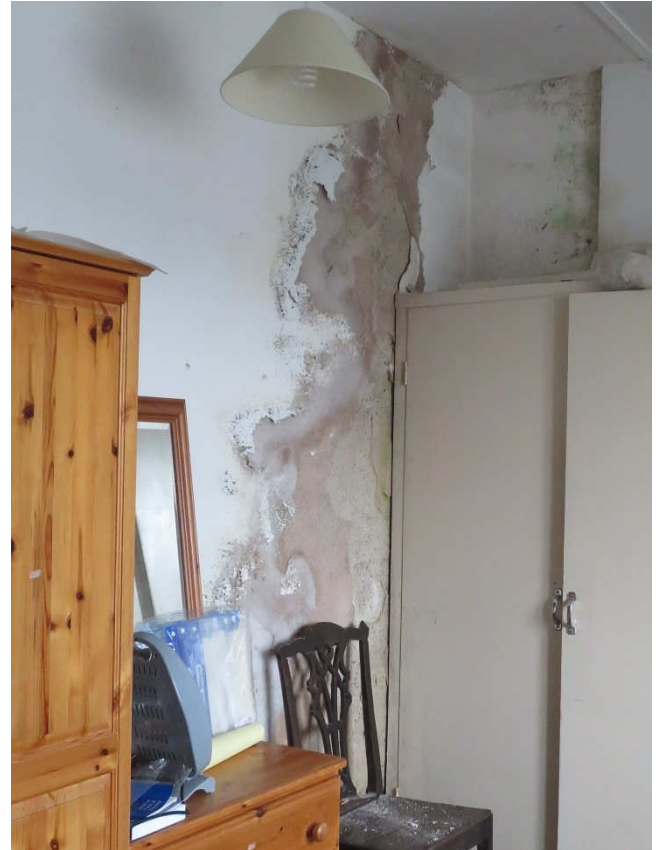
**Above :** Water damage to plasterwork / decorations in the vestry.

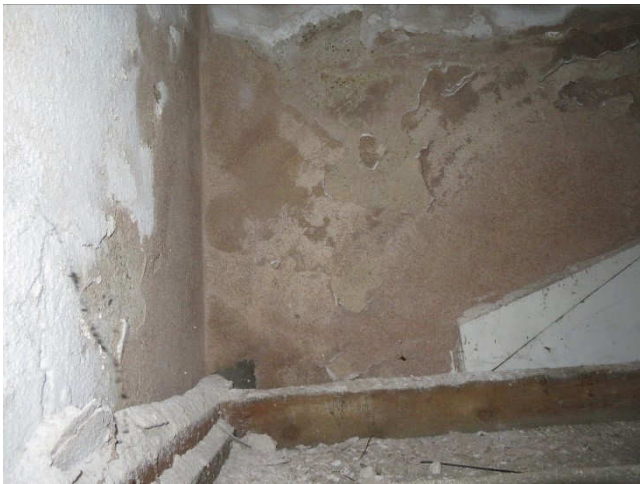
**Left :** Similar damage to plasterwork above the vestry ceiling.

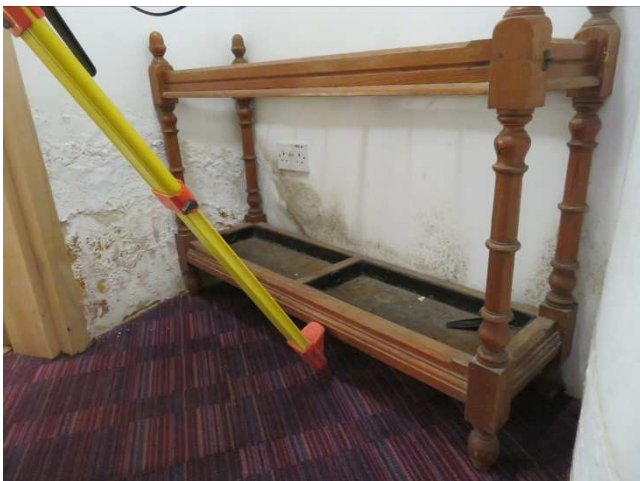
**Above :** dampness in the WC vestibule and associated condensation / mould growth is occurring in adjacent areas. Further investigation needed.

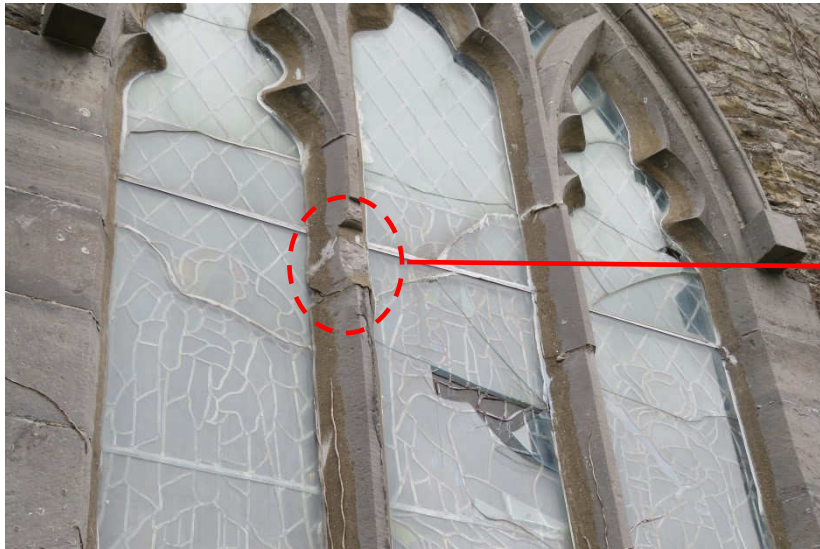
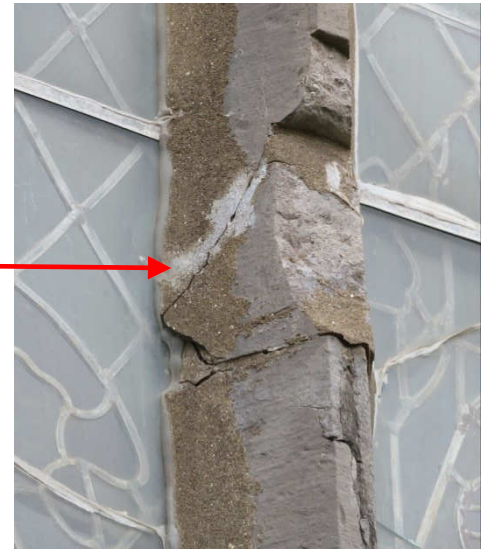
**Above :** Many of the windows on the south side of the church are overglazed externally. This glazing has largely failed, damaged by movement in the stonework caused by rusting iron. Extensive leaks.

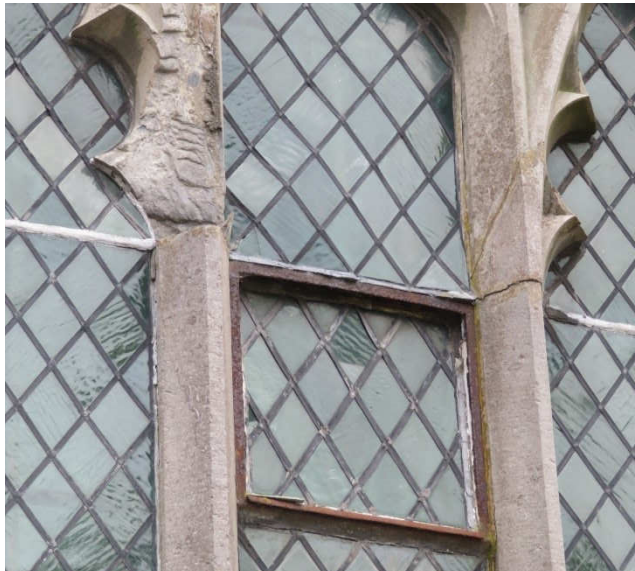
**Above :** Extensive and longstanding stone damage and glazing damage to most windows on the north side of the building, mainly caused by expanding metalwork (e.g. as below).

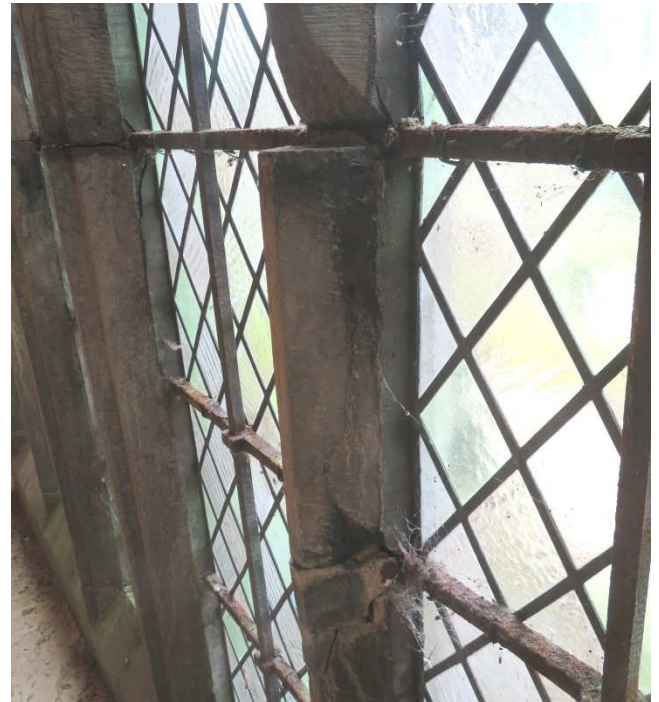
**Above :** North Aisle, East window. Superficially the glazing is in fair order but the extensive corrosion of metalwork internally, and associated stonework damage threatens stability and is buckling glass in places.

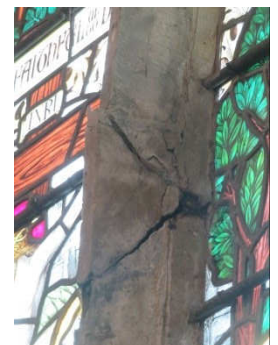
**Above :** Stone damage, east window (chancel).

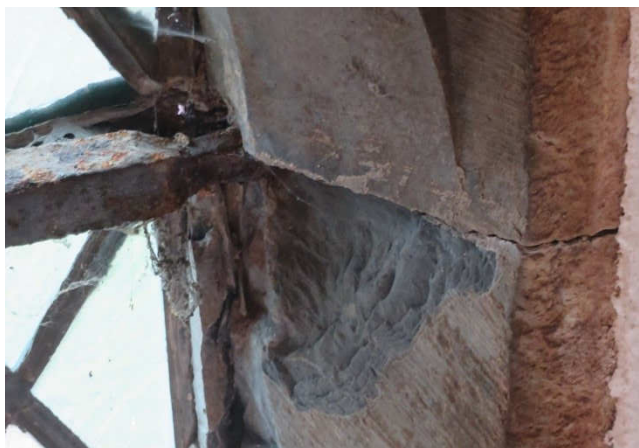
Andrew Faulkner Associates Ltd.

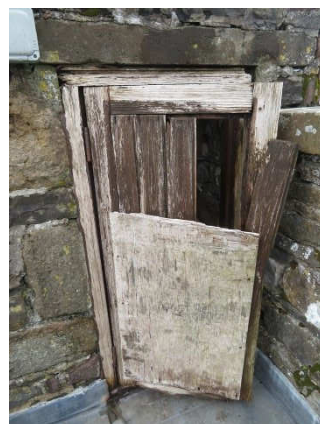
Above : Door in poor condition.

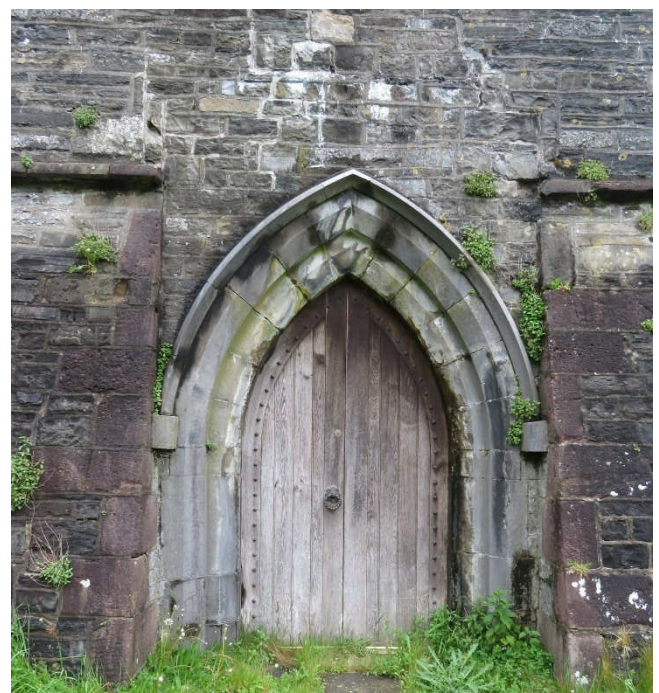
Above : Staining after rain and extensive vegetation growth indicates saturation in the base of the tower. Calcite streaks over the door may also indicate water

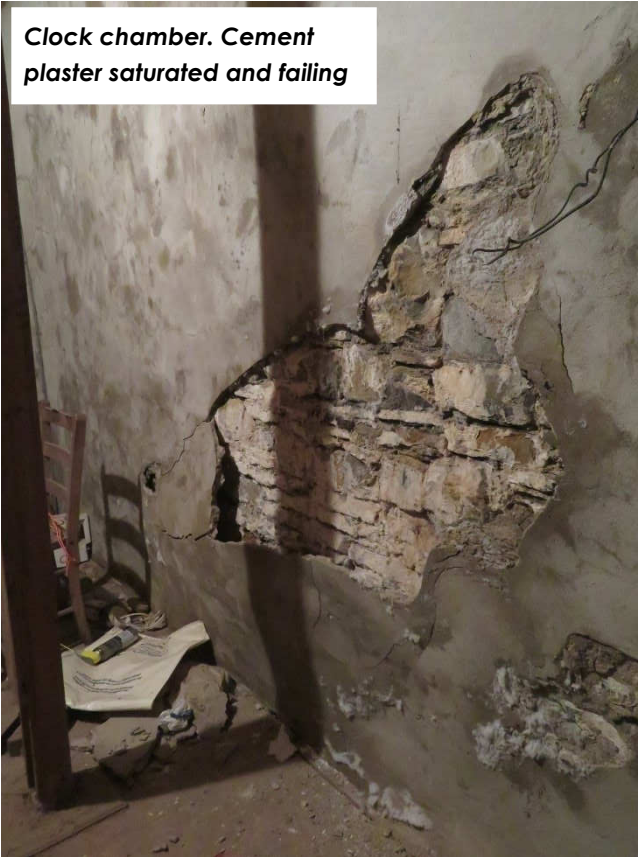
**Belfry floor - extensive rot.**

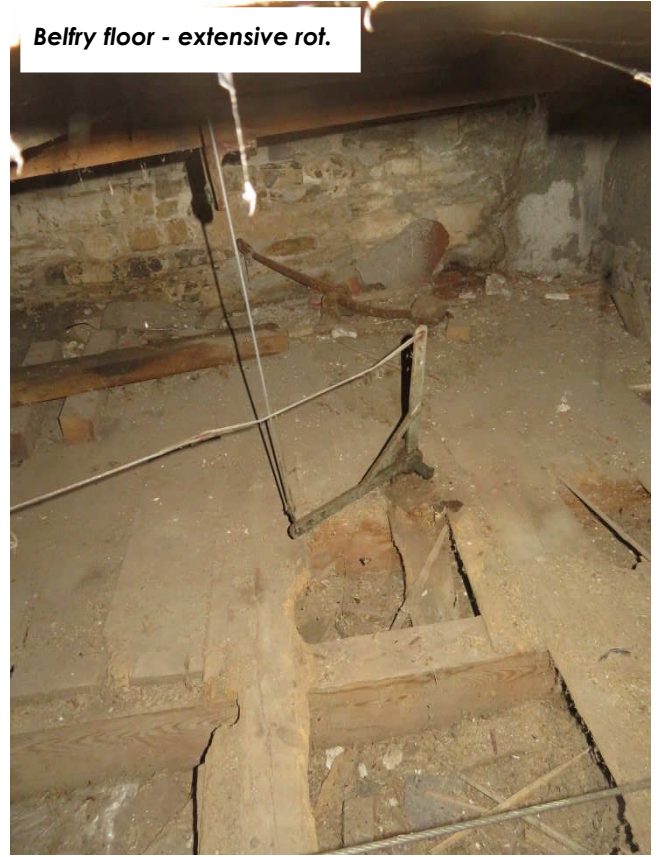
**Clock chamber floor. Decay and extensive beetle attack.**

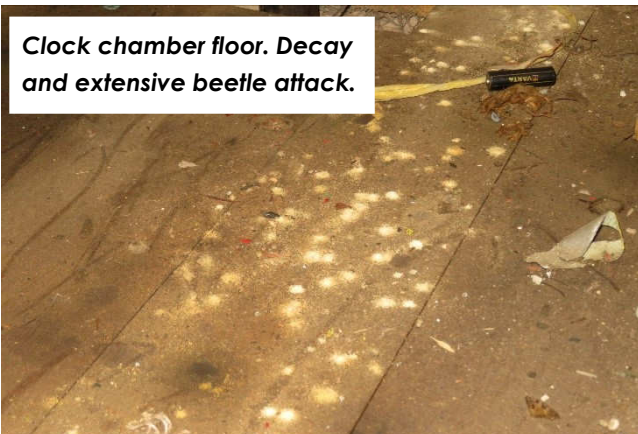
**Clock chamber ceiling. Extensive rot.**

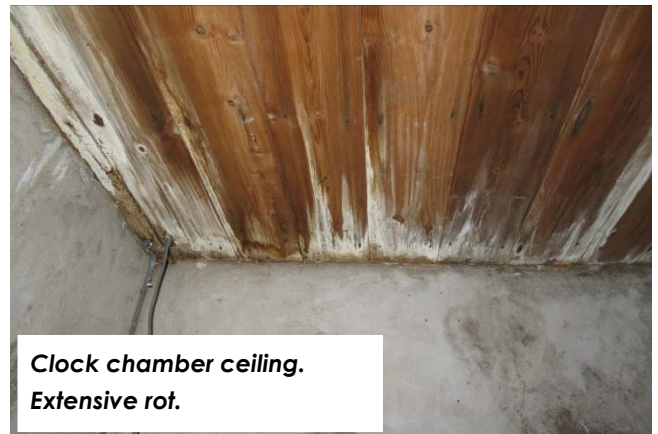
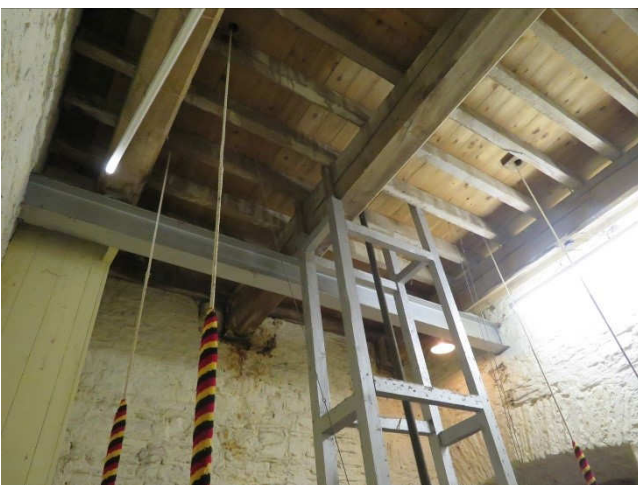
**Above :** Floor over the ringing chamber : Steel beams added to support rotting timber structure.

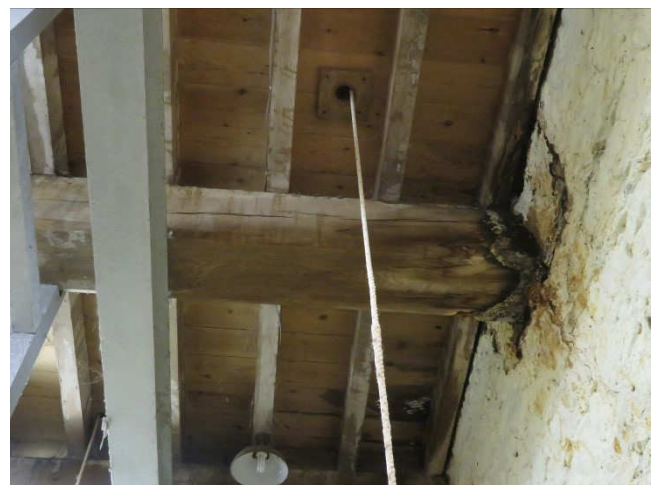
**Above :** Timber structure continuing to decay badly and needs attention.

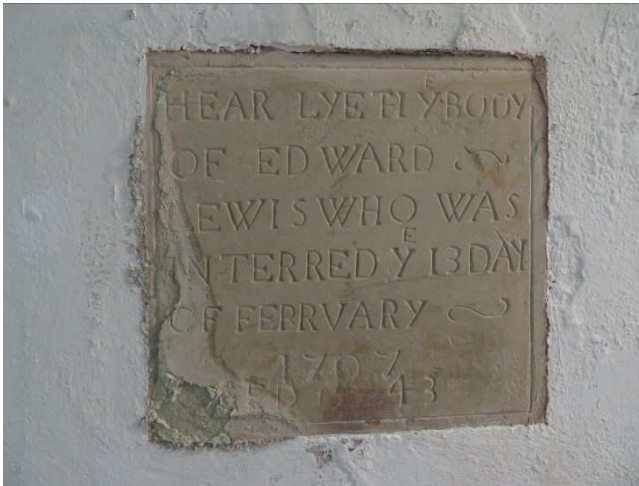
**Above :** One of the oldest monuments in the church, located in the north wall of the north aisle. Water is trapped in the wall by the cement plaster and forced to evaporate through the stone, causing damage through salt deposition and growth. Plaster should be removed to create a zone of evaporation around it.

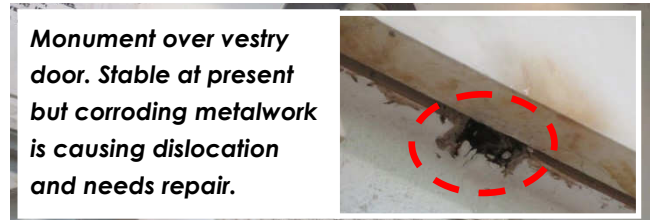
**Monument over vestry door. Stable at present but corroding metalwork is causing dislocation and needs repair.**

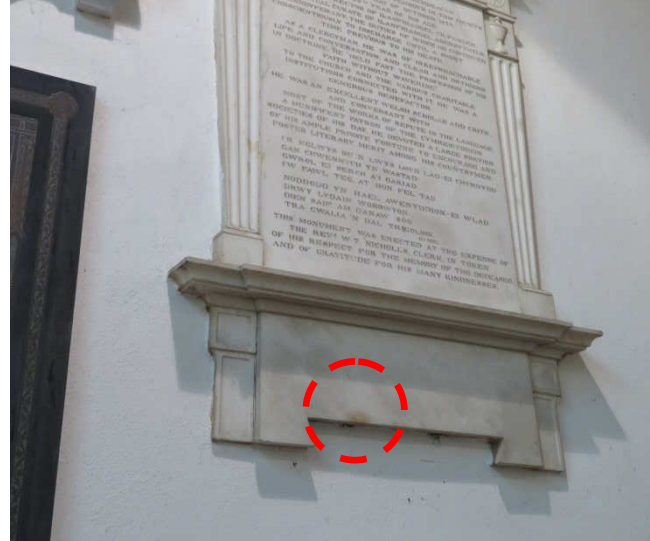
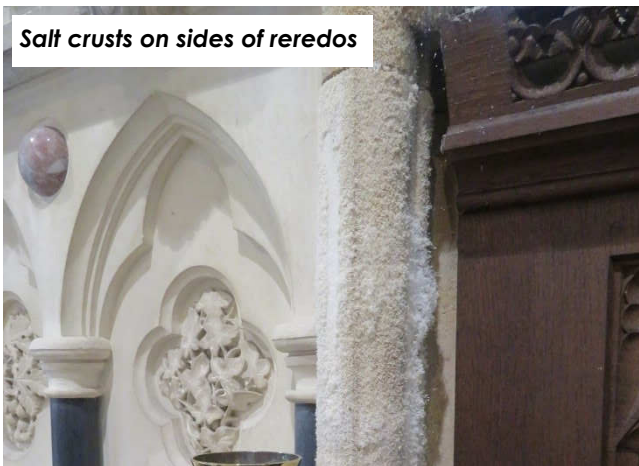
**Salt crusts on sides of reredos**

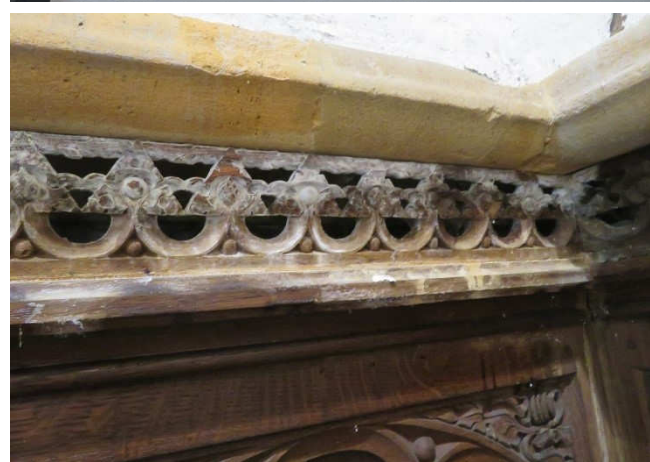
**Above and below left :** Water ingress is damaging the timber war memorial inscription panels at the east end : decay is evident in a number of locations. I suggest it is taken off the wall and repaired, and not reinstated until the damp issues have been fully addressed. **Below :** Longstanding water damage ('heave') in the sanctuary floor (south east corner).

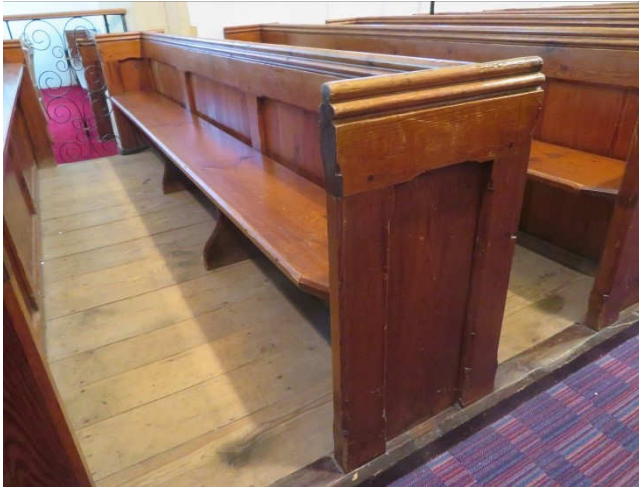
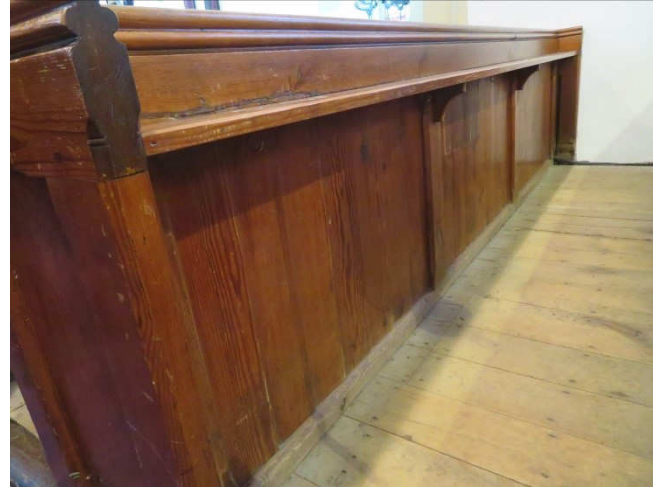
**Above :** The nave pews are very simple construction in pine, typical of the nineteenth century. They have vertical backs, and are apparently very uncomfortable for more than a short period. The pews sit on pine boarded raised platforms.

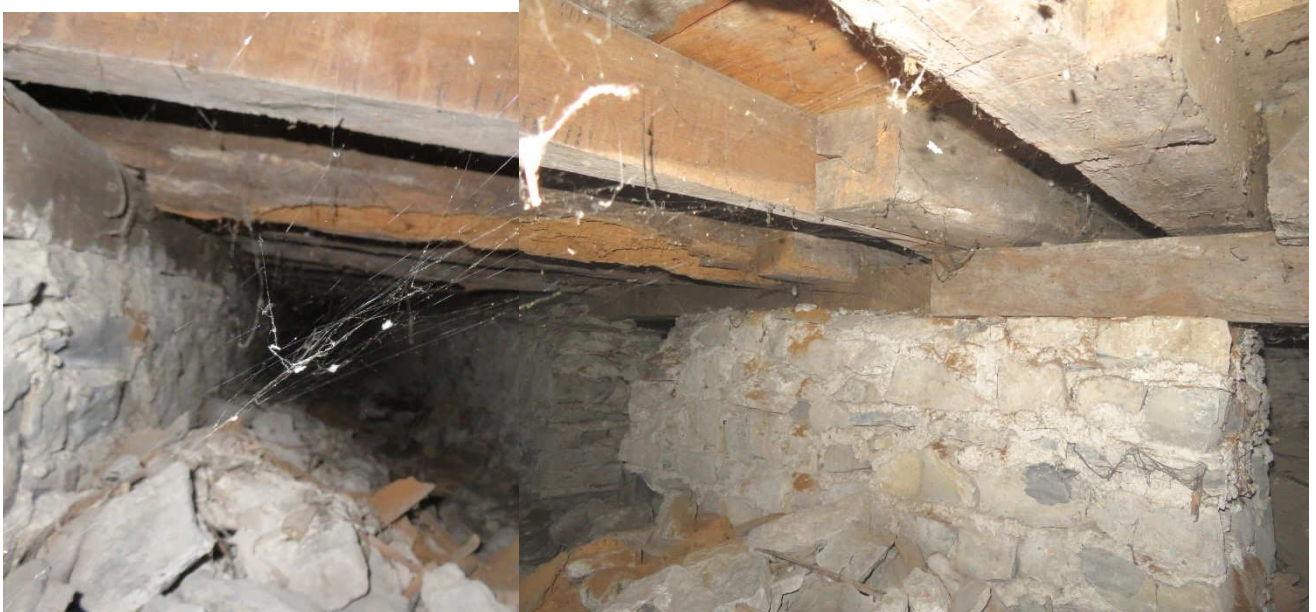
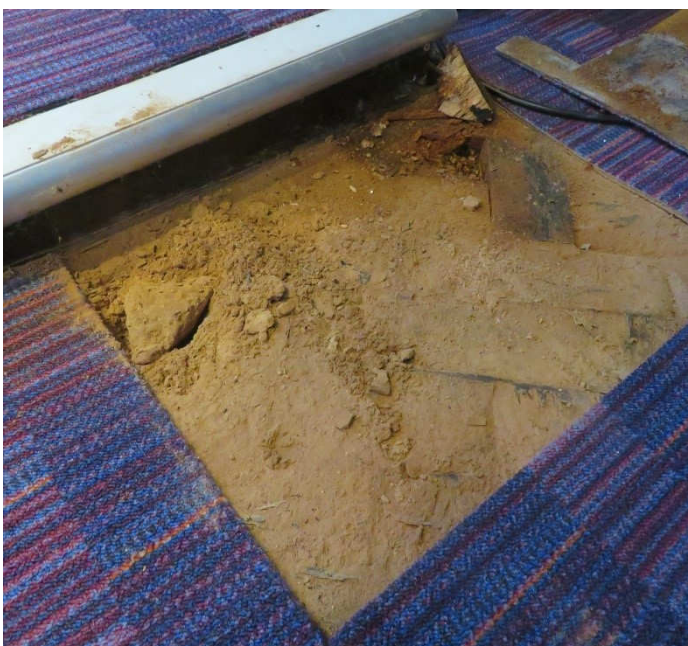
**Above :** Void beneath the pew platforms, approx. 1 metre deep. The structure incorporates historic timbers, possibly from an old roof structure (some carpenter's marks remain). The joists are supported by low stone walls running east / west along the north and south sides of the pew platforms and along the centre line (running in the same direction). Gaps are allowed for ventilation, but significant decay / beetle activity is present.

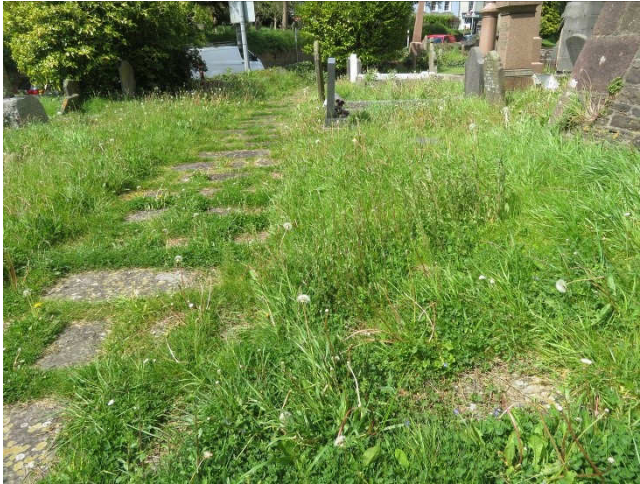
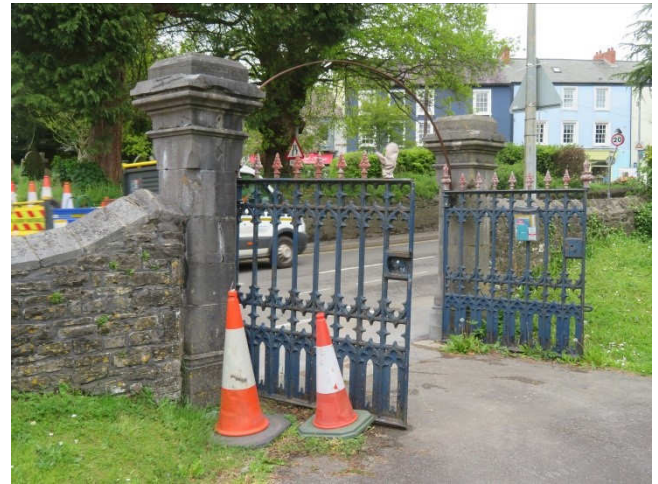
**Above :** Paths would benefit from greater maintenance. **Above Right :** Entrance gates would benefit from overhaul and redecoration.

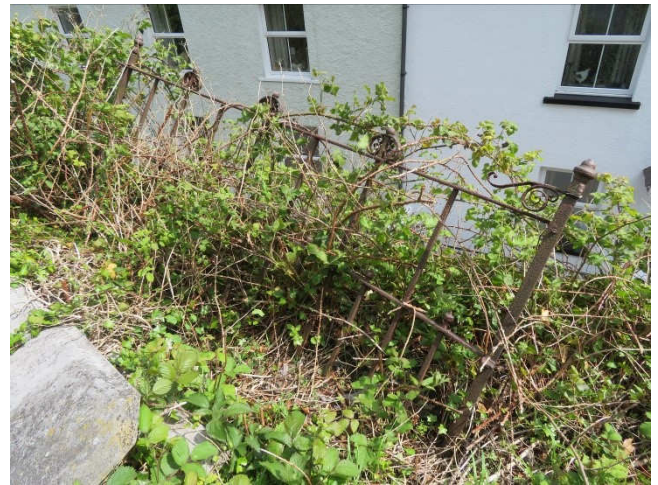
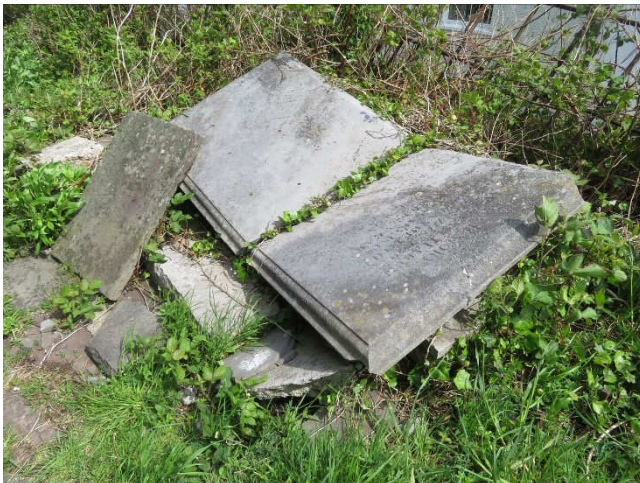
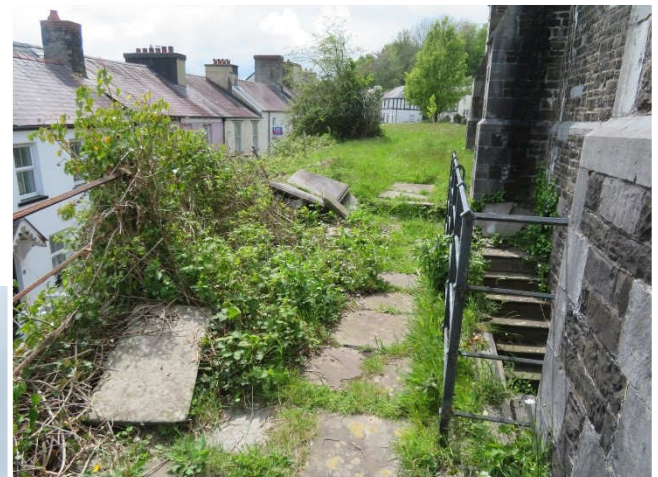
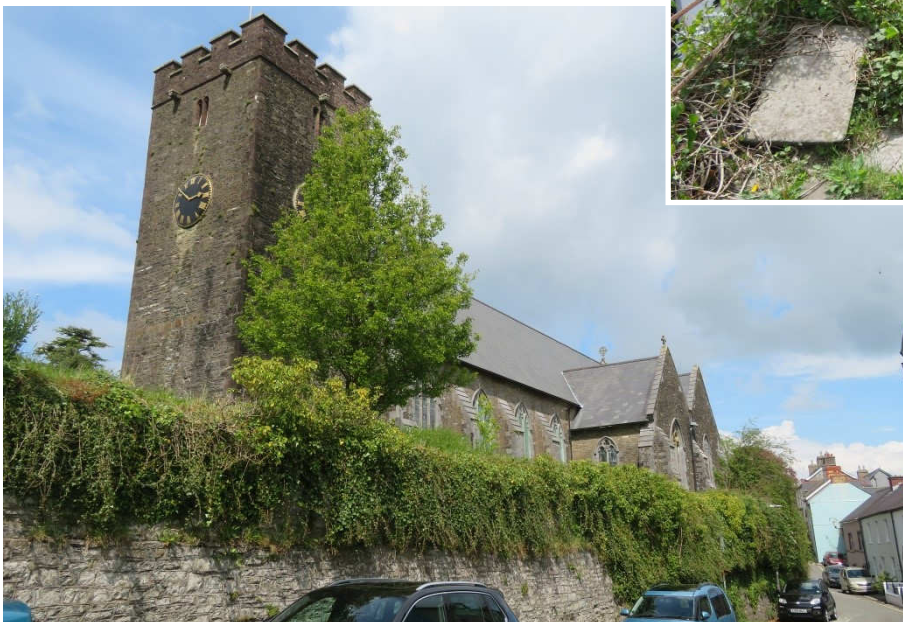
**Left :** Stone retaining wall to church street. Heavily overgrown, invasive vegetation may be causing damage out of sight. Potential hazard of people falling from the churchyard.
